**Flood Control Project Maintenance
Levee Inspections**

Fall 2019 Levee Maintenance Deficiency Summary Report

Sacramento River Basin

Reclamation District No. 1500 Sutter Basin

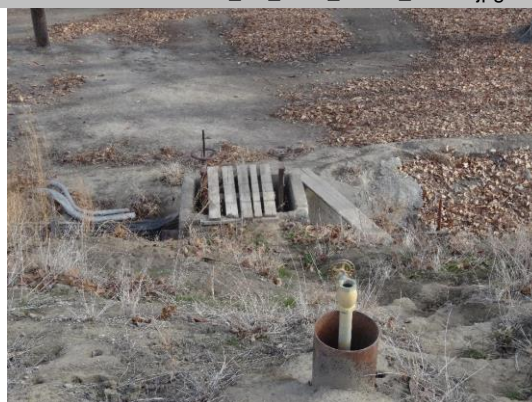
Photo 2 of 3 : UCIP_FA_2019_28183_51844.jpg

LS view: pressure breaker (bottom) in steel pipe riser and concrete distribution box on levee toe.

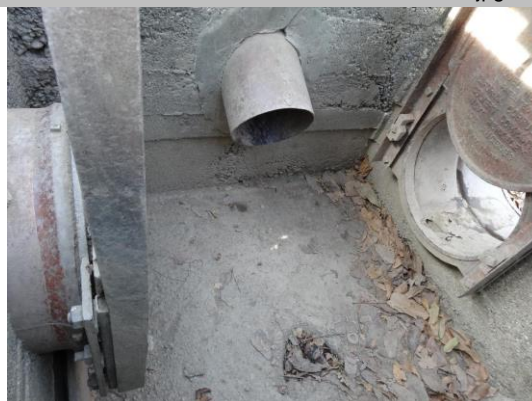
Photo 3 of 3 : UCIP_FA_2019_28183_51843.jpg

LS view: open steel pipe in concrete distribution box on levee toe.

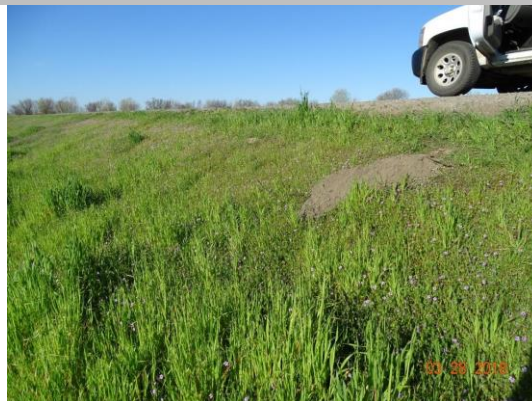
Photo 1 of 2 : FA_2019_RD1500_189_99_20190829_00042.jpg

View of rodent holes. Spring 2018

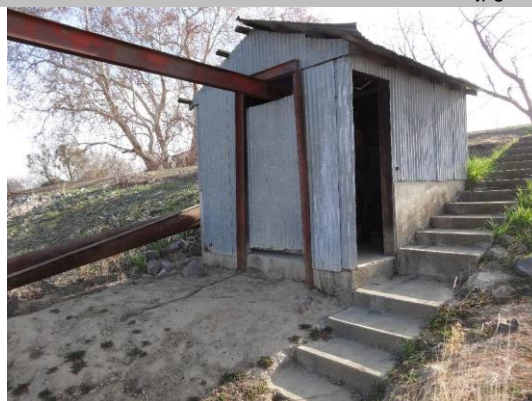
Photo 1 of 3 : UCIP_FA_2019_28903_53162.jpg

WS view: pipe (left), pump house/store, and concrete steps.

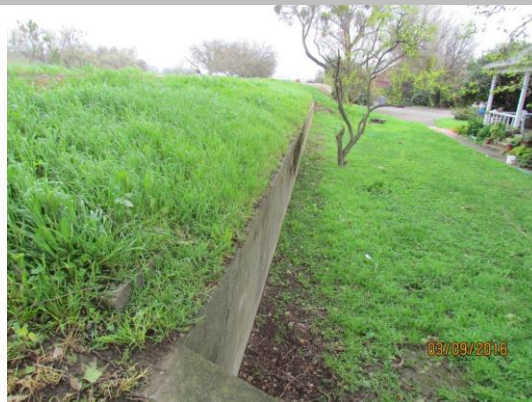
Photo 1 of 1 : FA_2019_RD1500_189_4_20190829_00001.jpg

View of the retaining wall that is in USACE as-builts on the landward side of the levee looking upstream. Wall cuts into levee toe. Spring 2016.

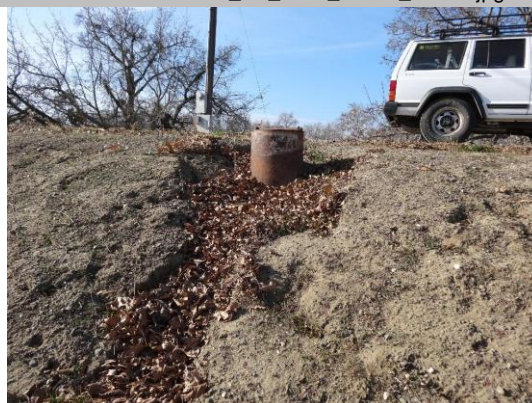
Photo 2 of 3 : UCIP_FA_2019_28263_51964.jpg

LS view: siphon breaker in CMP riser. Levee slope erosion due to leaky siphon breaker.

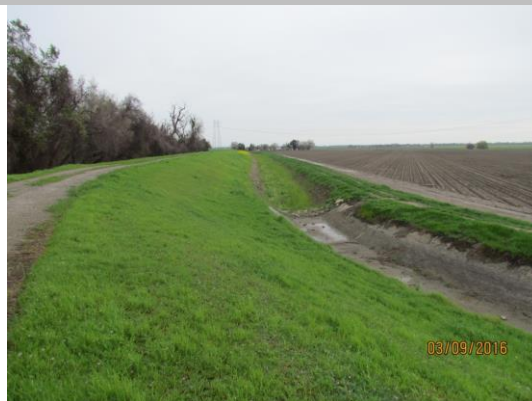
Photo 1 of 1 : FA_2019_RD1500_189_963_20190829_00073.jpg

View of the ditch at the toe of the landward side of the levee looking upstream. Spring 2016.

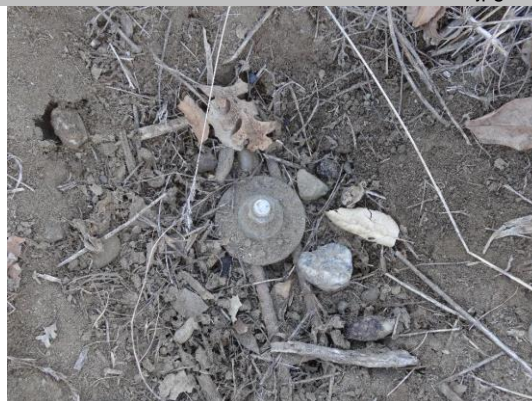
Photo 3 of 3 : UCIP_FA_2019_28913_53182.jpg

LS view: leaky and obstructed siphon breaker. Depression around siphon breaker due to leakage.

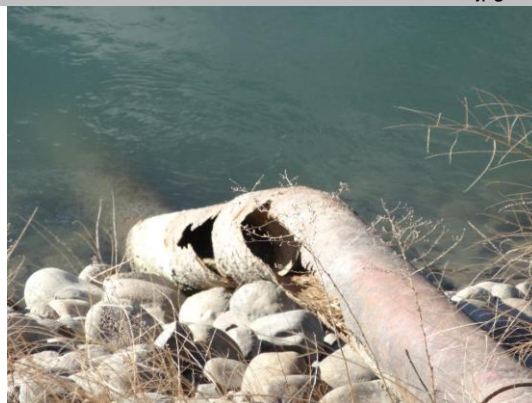
Photo 2 of 3 : UCIP_FA_2019_28923_53201.jpg

WS view: deteriorated and abandoned steel pipe on river bank.

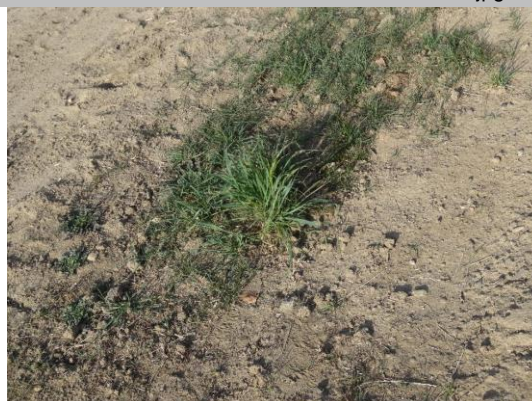
Photo 2 of 3 : UCIP_FA_2019_50199_53203.jpg

WS view: sign of leakage- excessive vegetation on levee slope.

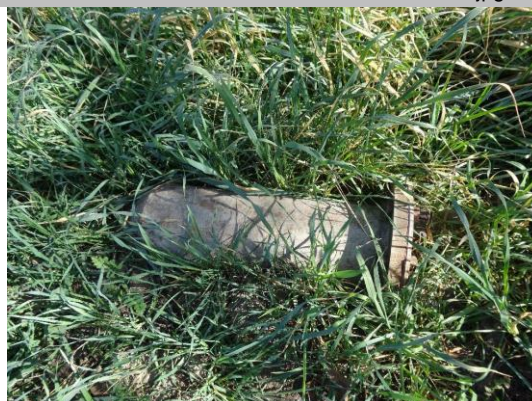
Photo 3 of 3 : UCIP_FA_2019_28363_52165.jpg

LS view: pipe end capped with steel plate on levee toe. Looks abandoned.

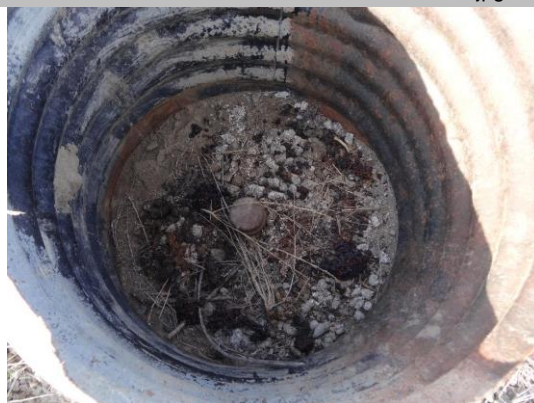
Photo 3 of 3 : UCIP_FA_2019_28925_53208.jpg

LS view: obstructed siphon breaker in CMP riser (bottom) on levee slope.

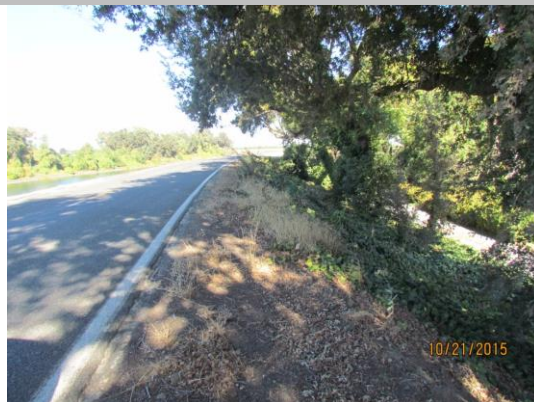
Photo 1 of 1 : FA_2019_RD1500_189_20_20190829_00007.jpg

View of the landscaping on the landward side of the levee looking upstream. Fall 2015.

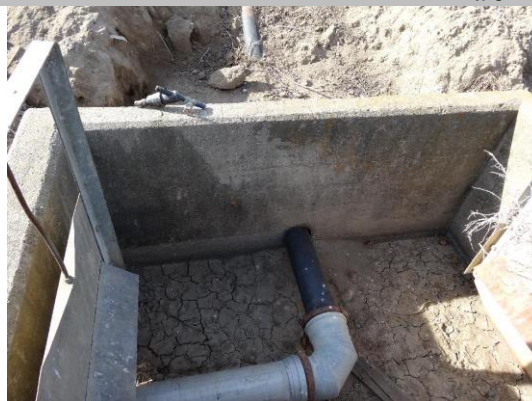
Photo 3 of 3 : UCIP_FA_2019_50198_52221.jpg

LS view: concrete distribution box on levee toe. Exposed pipe and depression (top) visible on levee slope.

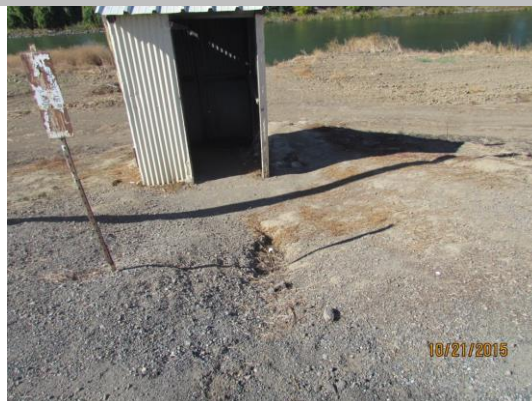
Photo 3 of 3 : FA_2019_RD1500_189_114_20190829_00051.jpg

There is slight erosion on the waterward side of the levee where the pipe seems to run through the levee. Fall 2015.

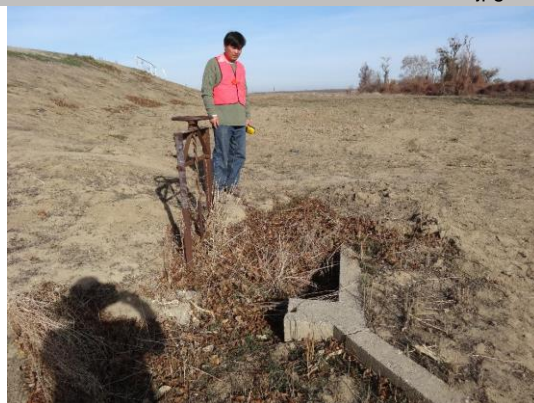
Photo 1 of 3 : UCIP_FA_2019_50197_52425.jpg

WS view: slide gate (left) in concrete box at levee toe. Slide gate and the box mostly buried.

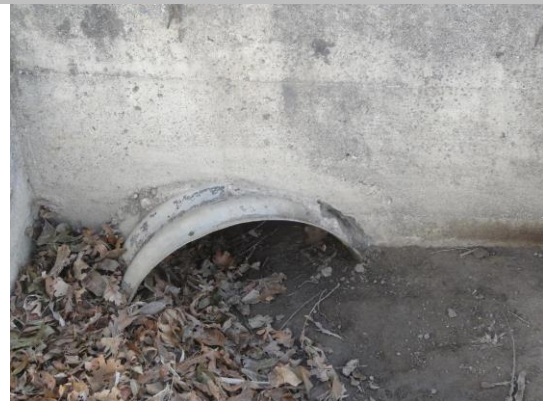
Photo 3 of 3 : UCIP_FA_2019_50197_52423.jpg

LS view: silted CMP in concrete intake box on levee toe.

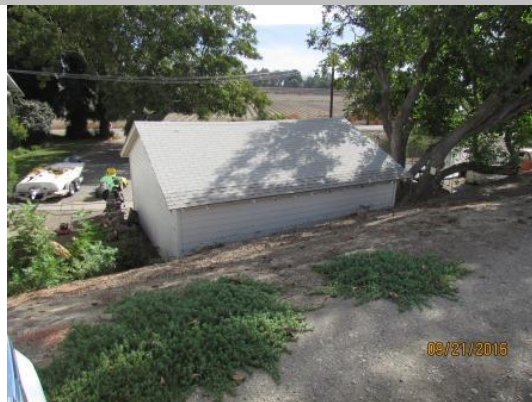
Photo 1 of 1 : FA_2019_RD1500_189_138_20190829_00065.jpg

View of a building encroaching the levee on landside toe. Fall 2016.

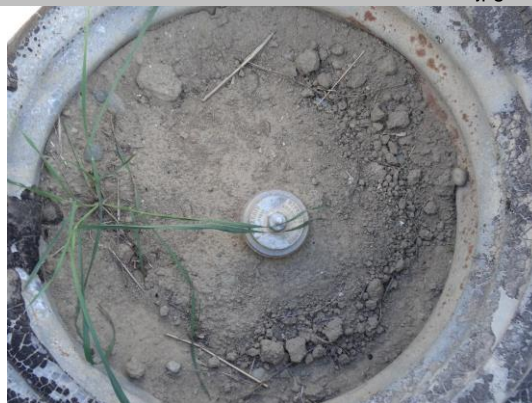
Photo 3 of 3 : UCIP_FA_2019_28527_52566.jpg

LS view: obstructed siphon breaker in CMP riser on levee slope.

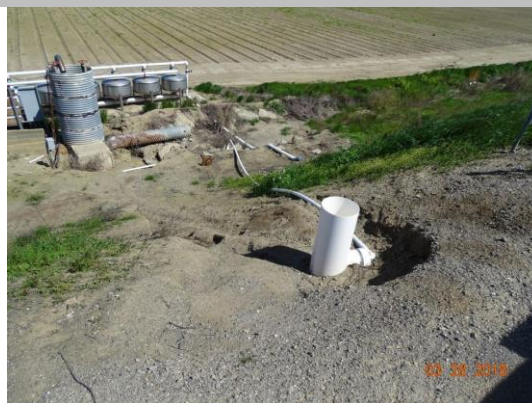
Photo 1 of 1 : FA_2019_RD1500_189_120_20190829_00057.jpg

View of erosion around PVC standpipe. Spring 2018.

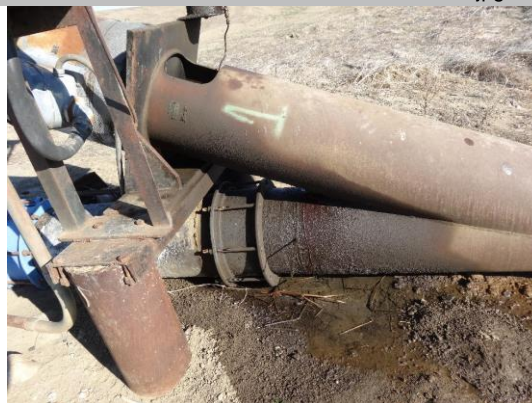
Photo 2 of 3 : UCIP_FA_2019_28528_52575.jpg

WS view: leaky inlet pipe near pump platform.

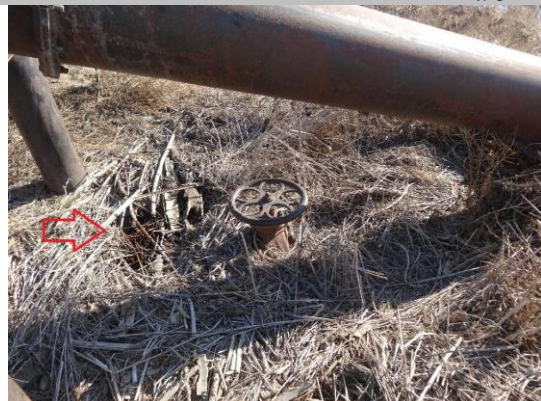
Photo 2 of 3 : UCIP_FA_2019_28583_52626.jpg

WS view: gate valve beneath slant pipe on levee berm. Water leaking from this pipe (marked).

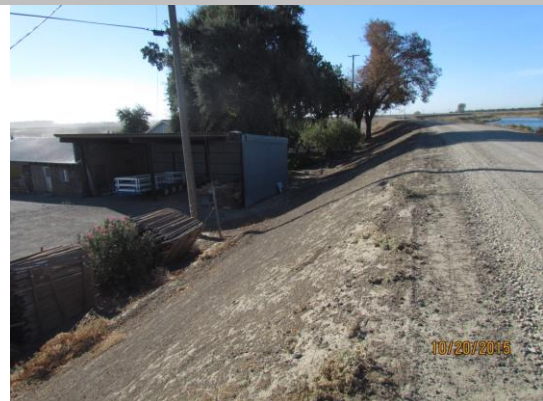
Photo 1 of 1 : FA_2019_RD1500_189_42_20190829_00018.jpg

View of the barn and equipment on the landward side of the levee looking downstream. Fall 2015.

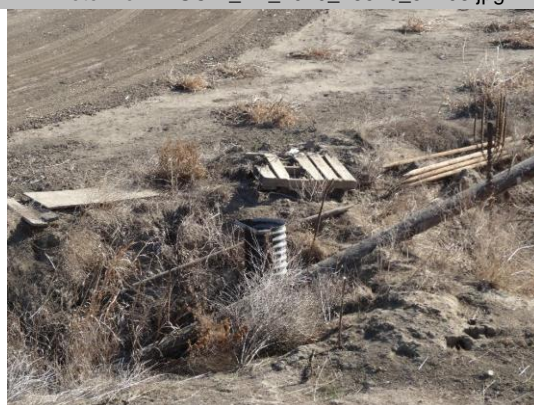
Photo 2 of 2 : UCIP_FA_2019_28629_52708.jpg

LS view: abandoned CMP risers on levee toe.

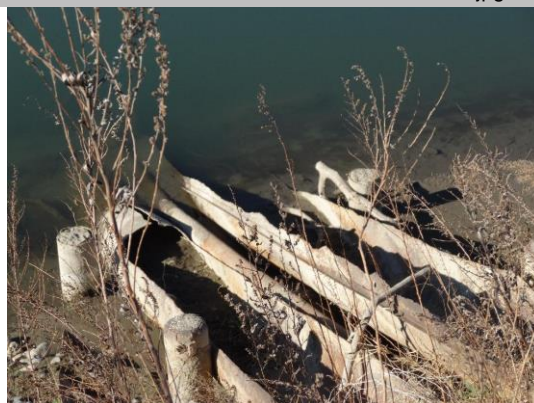
Photo 1 of 2 : UCIP_FA_2019_28628_52705.jpg

WS view: abandoned 24" and 30" steel pipe on river bank.

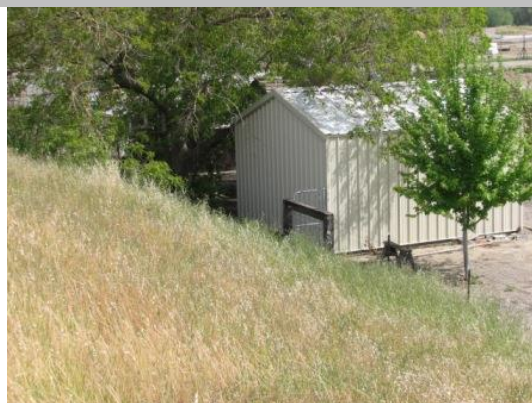
Photo 1 of 1 : FA_2019_RD1500_189_46_20190829_00020.jpg

The building is within the easement of the levee toe.

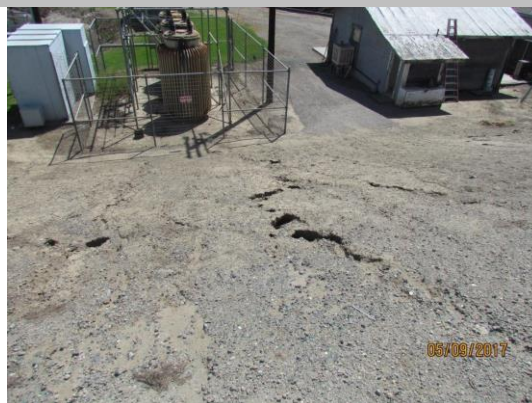
Photo 1 of 1 : FA_2019_RD1500_189_144_20190829_00067.jpg

View of erosion on landside slope. Spring 2017.

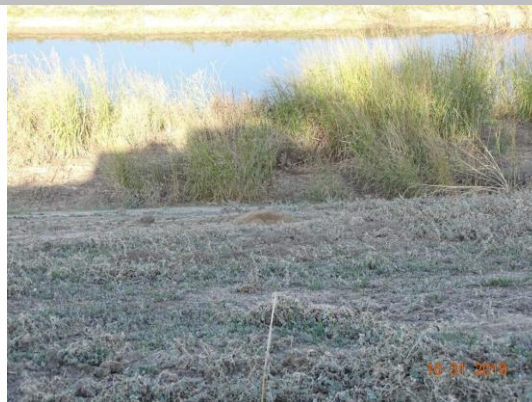
Photo 1 of 1 : FA_2019_RD1500_190_20_20191104_00042.jpg

View of rodent hole on the landside slope. Fall 2019.

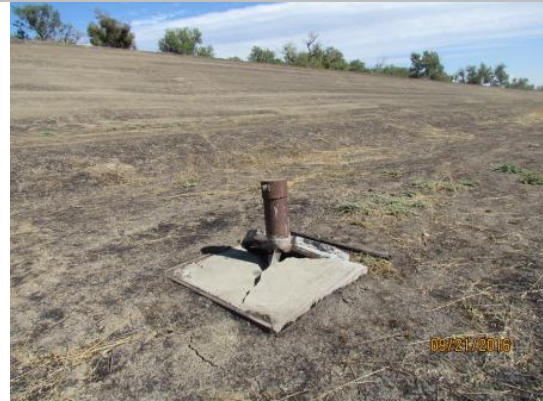
Photo 1 of 3 : FA_2019_RD1500_190_4_20190829_00001.jpg

View of underseepage relief well with destroyed concrete pad as well as PVC pipes. Fall 2016.

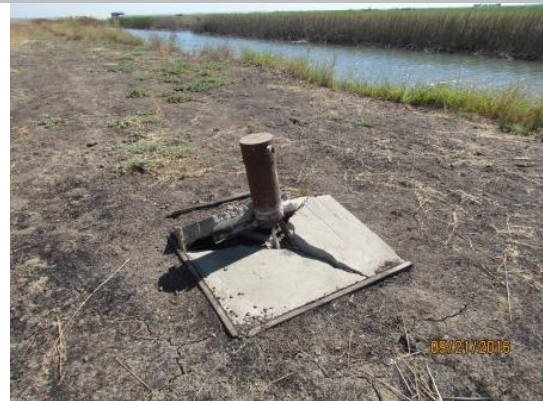
Photo 2 of 3 : FA_2019_RD1500_190_4_20190829_00002.jpg

Another view of damaged well. Fall 2016.
